PRACE NAUKOWO-PRZEGLĄDOWE RESEARCH REVIEW PAPERS

Beata NOWOGOŃSKA

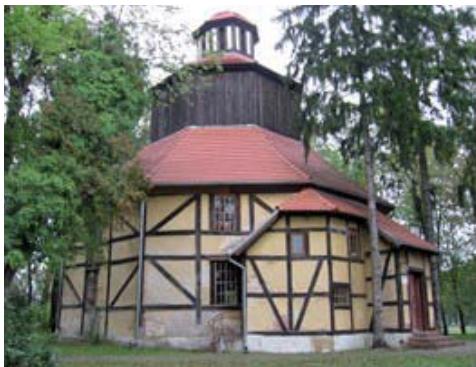
FIGURE 1. The south-western elevation. Damaged and damp foundation plinth, corroded wooden structure, significant missing areas of plaster in the masonry wall filling the post and beam structure

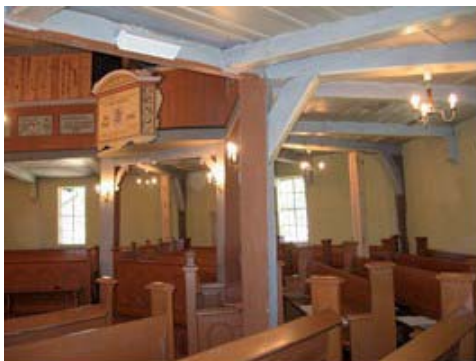
FIGURE 2. Inside of the church

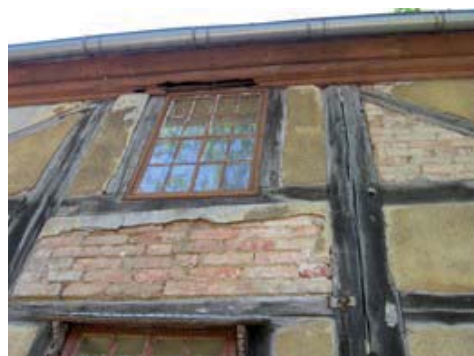
FIGURE 3. Northern elevation – fragment. The corroded wooden post and beam structure. Loose brick connections, missing plaster. Corroded attached canopies over the ground-floor window

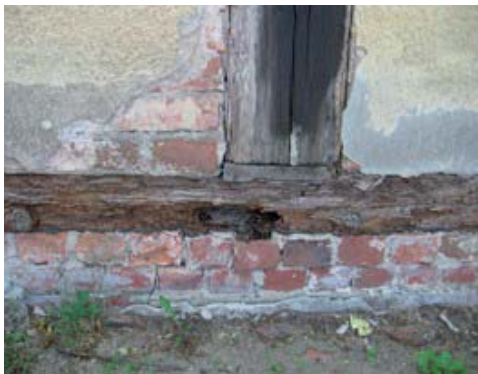
FIGURE 4. Northern elevation. Corroded ground beam, loosened connections of plinth brick, missing areas of plaster. Between the post and the corroded and crushed ground beam, the crevice is filled with an insert from boards

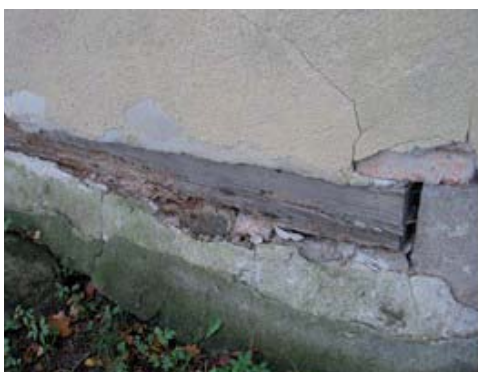
FIGURE 5. North-western elevation – fragment. The corroded and compressed ground beam. Damp foundation plinth

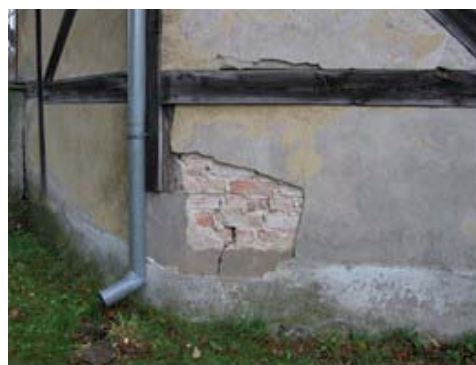
FIGURE 6. Fragment of the south-western elevation. Cracking of the plinth in the corner between the south-western wall, missing plaster, cut-out fragment of post

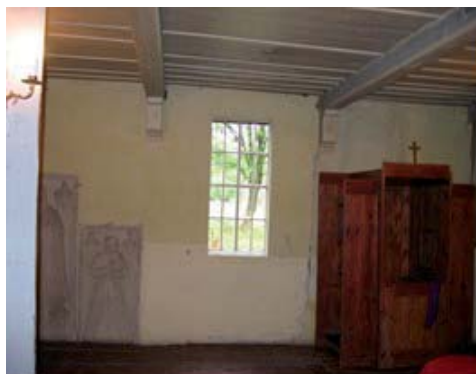
FIGURE 7. Inside part of the north-eastern wall. Vertical cracks of the wall along the posts

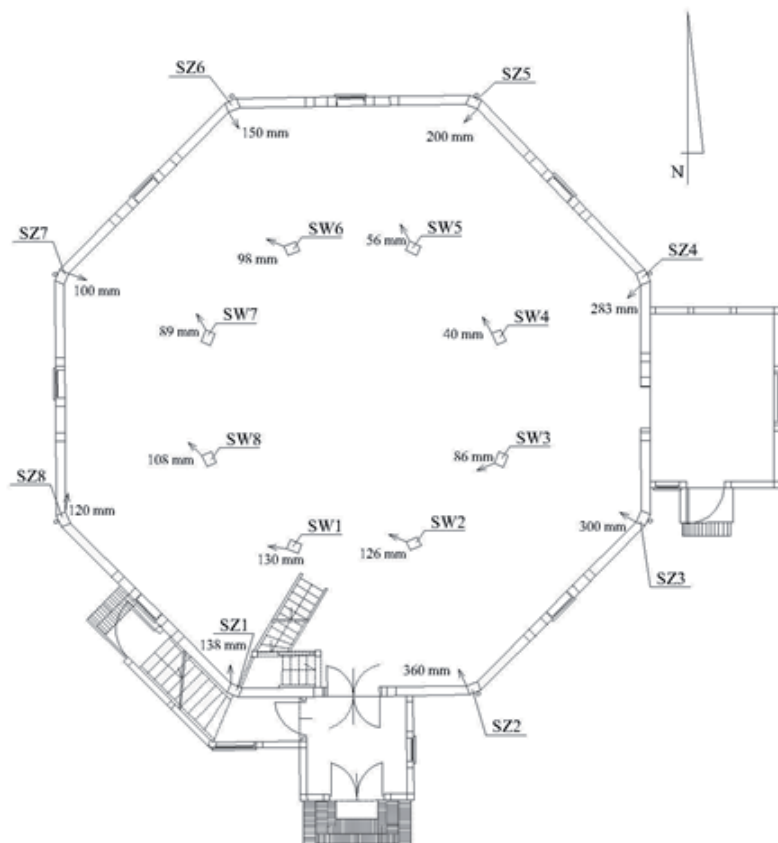
FIGURE 8. Values of deviation from the vertical of inside posts (SW1–SW8) and posts in the outside walls (SZ1–SZ8)
