Support vector regression tree model for the embankment breaching analysis based on the Chamoli tragedy in Uttarakhand

Keywords: embankment breaching, multi-objective data, catastrophic collapses, rock-ice avalanche, Chamoli tragedy

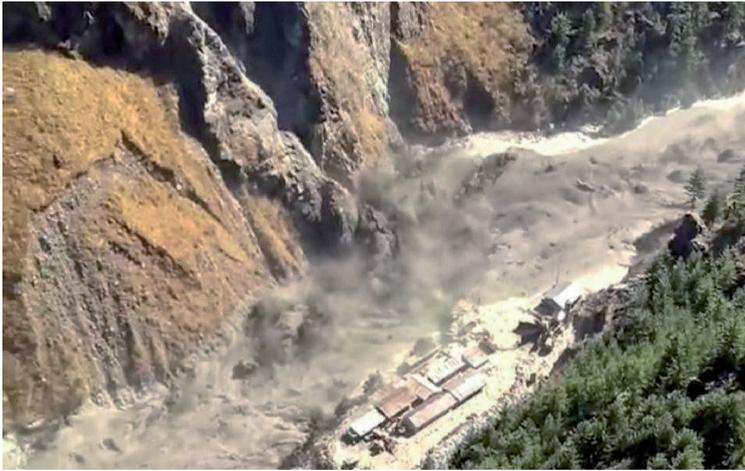
A large landslide happened on 7 February 2021, in the remote Chamoli district of northern India's Uttarakhand state. The avalanche originated on the Ronti Glacier, which is located at 79.732° E longitude and 30.3750° N latitude. Because the catastrophic flood was discovered in the middle of the day in the Rishi Ganga river, a tributary of the Ganges, it was first described to as a 'glacial' burst or glacial lake outburst flood disaster (Rana et al., 2021). As a result, the occurrence was named a rock ice avalanche. However, satellite pictures indicated that the source location is mostly

FIGURE 2. Outburst of avalanche of ice rock

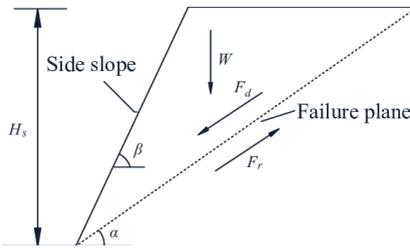
Changes in slope gradient are a common source of landslides and other types of mass waste. A change in slope gradient alters the internal tension of the rock or soil mass, whereas a change in shear stress alters the distribution of equilibrium conditions (Fig. 6).

FIGURE 6. Failure plane of slope

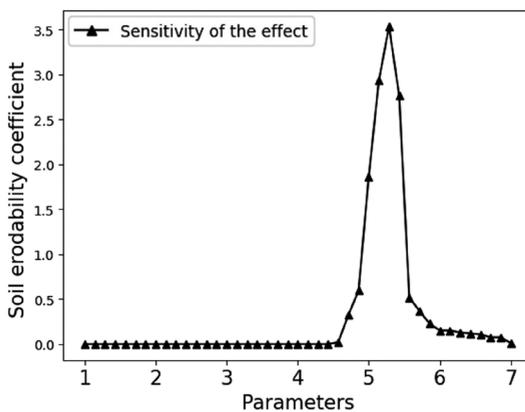
The soil erodibility coefficient (k_d) was multiplied by 0.5, 1.0, and 2.0 to test the model’s sensitivity, while all other parameters remained fixed (Fig. 7). The sensitivity analysis findings for k_d are displayed (Fig. 8). Breach hydrographs with varied k_d values were created because breach flow discharge is critical for disaster consequences.

FIGURE 7. Soil erodibility coefficient
Source: own elaboration.

Because the height of the landslide dam had a direct influence on the storage capacity of the dammed lake, the output parameters of peak breach flow and breach breadth rose significantly for the dam without a spillway.

However, the eventual breach size increased somewhat with increasing k_d due to the rising soil erodibility coefficient with depth and the quick attenuation of hydrodynamic conditions in the case of a big peak breach

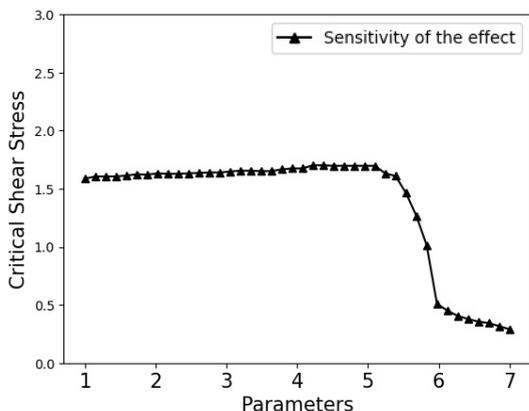
FIGURE 8. Critical shear stress

The sensitivity analysis results showed that the soil erodibility coefficient had a significant influence on the landslide dam breach process, but the soil critical shear stress had a minor impact. Furthermore, early spillway excavation in dammed lakes with large reservoir capacity can considerably lower the peak flow generated by a landslide dam failure. However, given the growing rate of the water level rise and construction capacity, the spillway's construction circumstances and sectional design should be evaluated holistically.

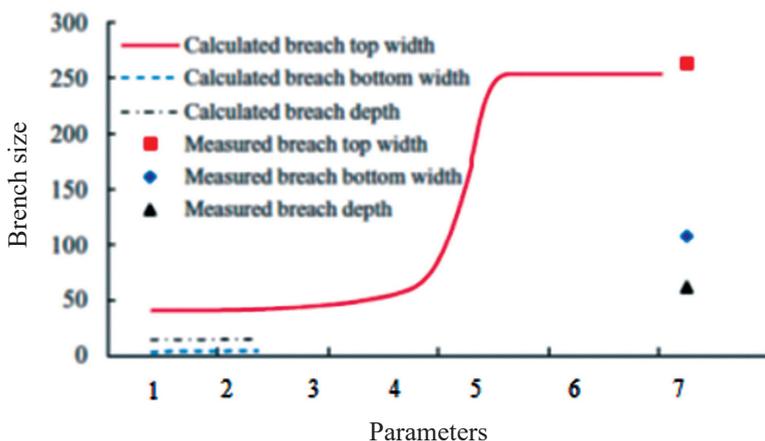
FIGURE 9. Breach size

flow (Fig. 9). According to the sensitivity analysis results, peak breach flow and peak discharge time were more susceptible to the erodibility coefficient, but breach size was less sensitive.
